Circular 196-AN/119

AIRCRAFT ACCIDENT DIGEST 1983 (No. 30)

On January 11, 1983, United Airlines Flight 2885, a McDonnell Douglas DC-8-54F, N8053U, was being operated as a regularly scheduled cargo flight from Cleveland, Ohio, to Los Angeles, California, with an en route stop at Detroit, Michigan. United 2885 departed Cleveland at 0115 and arrived at the Detroit Metropolitan Wayne County Airport at 0152, where cargo for Detroit was unloaded, the airplane was refueled, and cargo for Los Angeles was loaded. At 0249:58, United 2885 called for clearance onto runway 21R and was cleared for takeoff at 0250:03. Visual meteorological conditions prevailed at the time, and the company had filed and been cleared for a standard IFR flight plan.

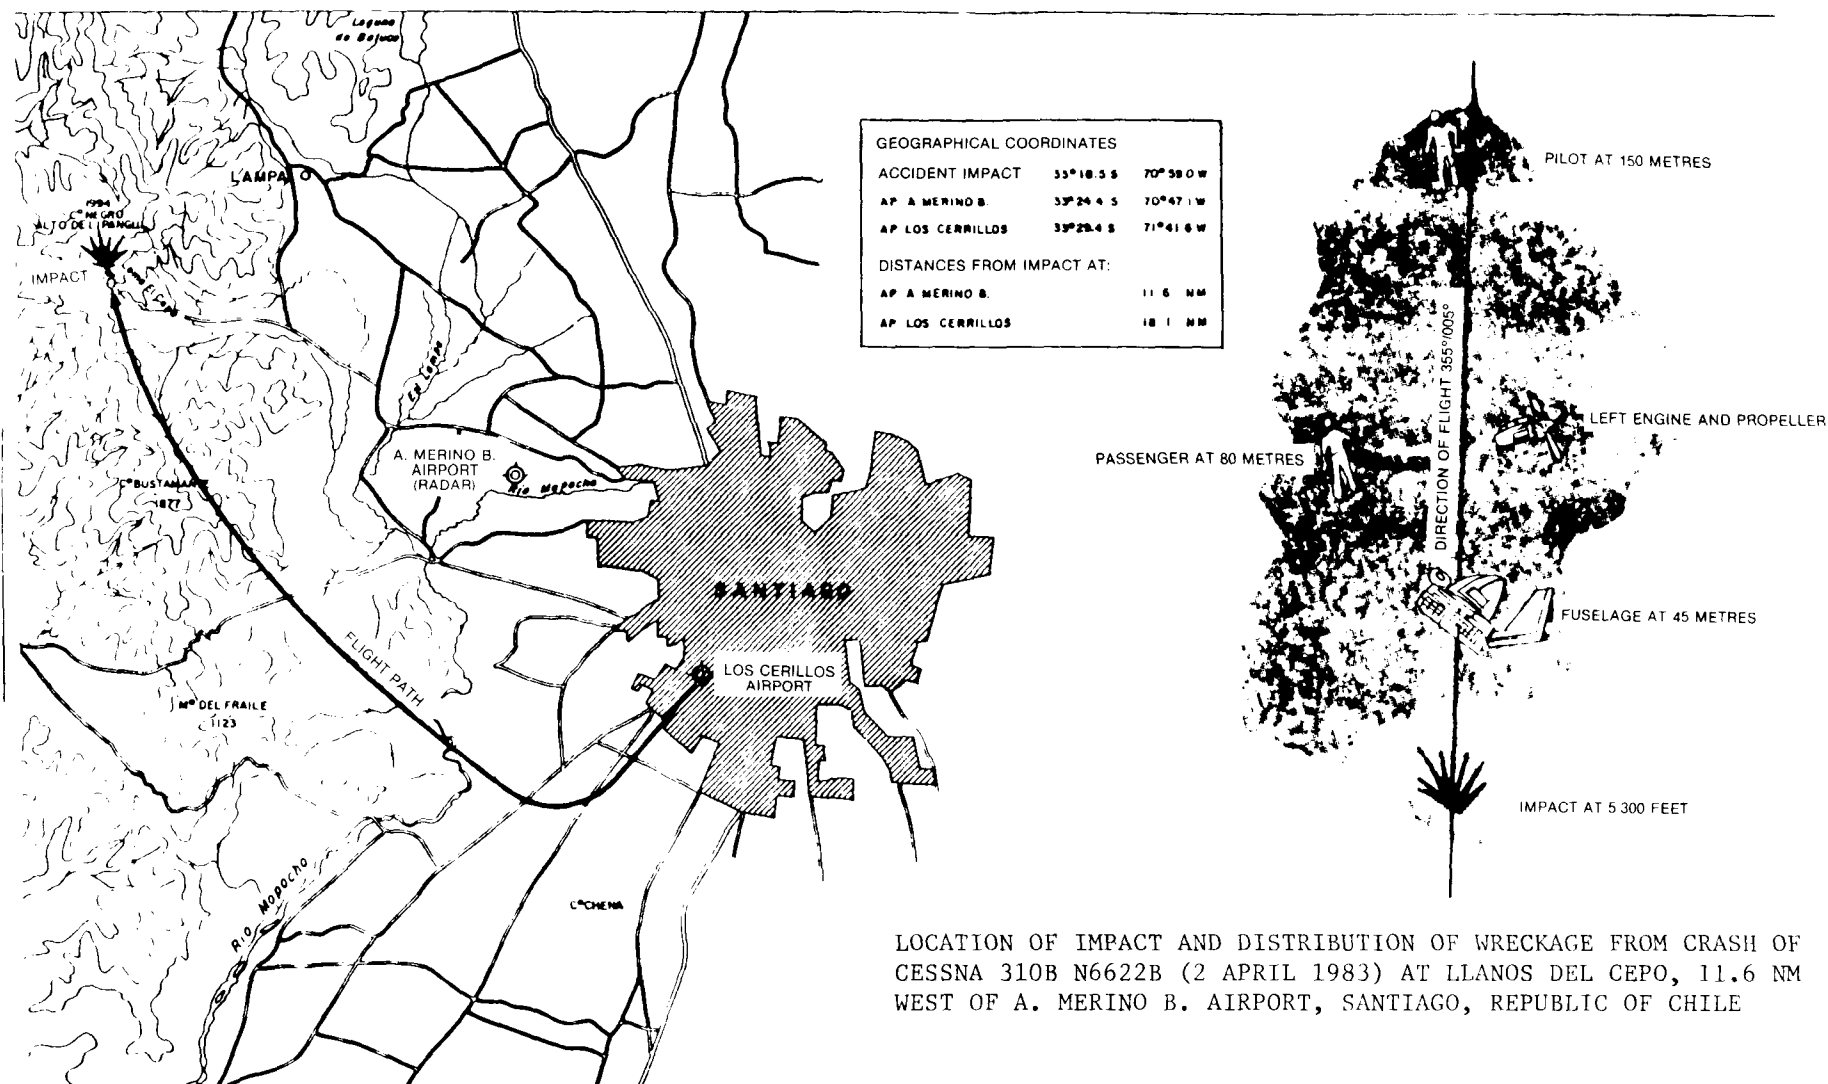
APPENDIX A

The aircraft was found totally destroyed at latitude 33° 18.5 S, longitude 70° 59W and at an elevation of 5 300 ft. The aircraft, in a general attitude of level flight, collided head-on with the east side of a mountain range 6 500 - 7 000 ft in height. Impact was sudden and occurred while at cruising speed. The left wing struck before the right wing (by a fraction of a second), and this fact, together with the configuration of the terrain at the crash site, caused the fuselage, which had been crushed and compressed by the impact, to be projected in an inverted position for a distance of 45 m. The magnetic heading of flight was 355°/005°. The left-hand engine broke away and was thrown a distance of 90 m in the direction of flight. One of the passengers was projected a distance of 80 m and the pilot was found 150 m from the collision site. All the scattered components had been thrown in the direction in which the aircraft had been flying. The location is virtually inaccessible for purposes of removing the wreckage. Appendix "A", attached, contains a sketch of the impact and wreckage. Photographs are found in Appendix "B".
